Hurricane Isabel: A case study in restoration response at three Mid-Atlantic national seashores

By Rebecca Beavers and Julia Brunner

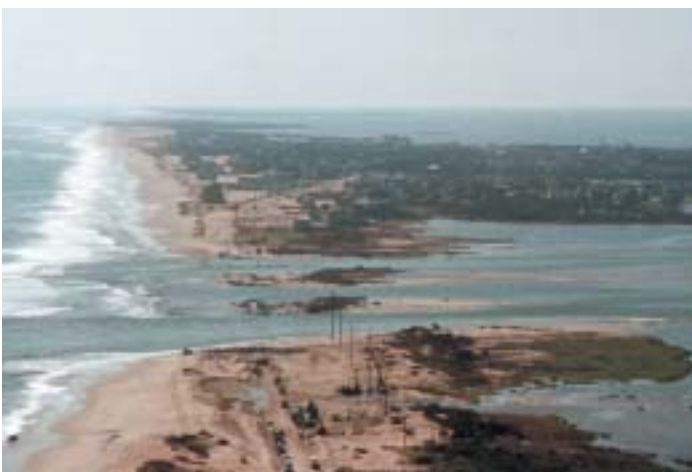
A 1,700-foot passage between the Atlantic Ocean and Pamlico Sound at Cape Hatteras National Seashore, North Carolina, was created on September 18, 2003, when 25-foot waves and a storm surge caused by Hurricane Isabel slammed into the Outer Banks. The breach was subsequently filled and the road reconstructed within two months of the storm.

their prestorm mode of travel along asphalt roads. The situation was considered an emergency because no other means of access, such as bridge, causeway, or ferry, is available to the village. Accordingly, the U.S. Department of Homeland Security directed the Army Corps of Engineers to fill the new inlet. Once the inlet was filled, the state transportation department reconstructed the broken segment of highway.

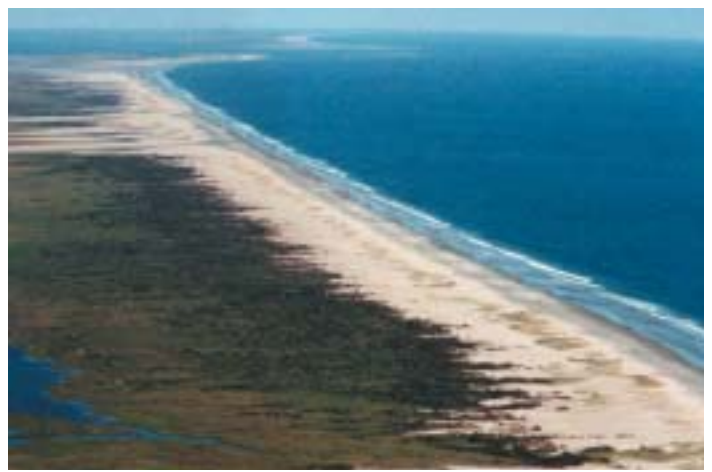
South of Cape Hatteras, Cape Lookout National Seashore has no permanent road. Sediments that washed over the park have been preserved as geologic features for visitors to explore and contemplate.
